B-HCE Report Number 44-22003 – Pendant Properties, LLC Attachments

Photographs

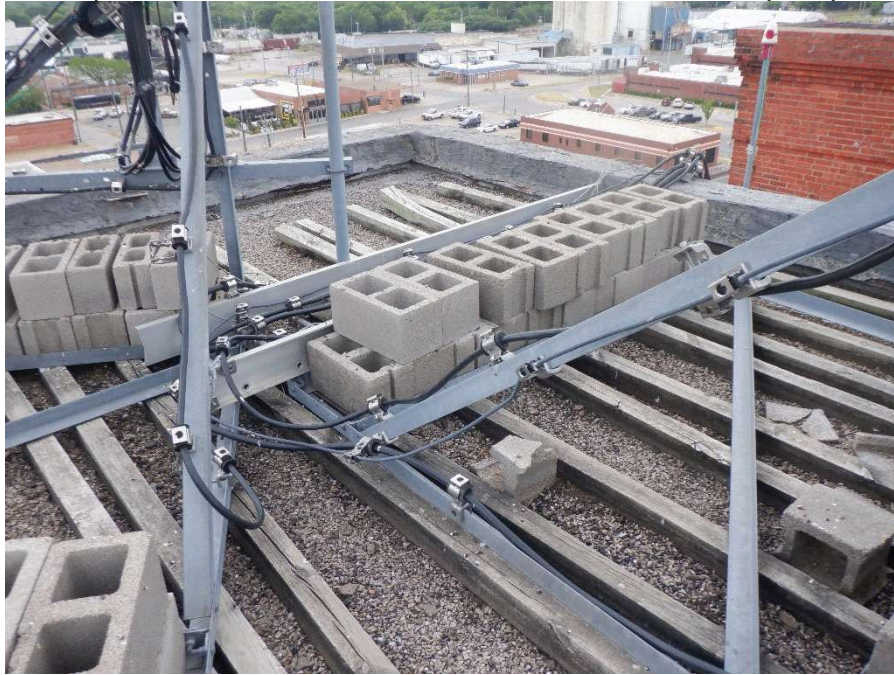
View of the penthouse roof with GB BUR and bitumen clad parapet wall.

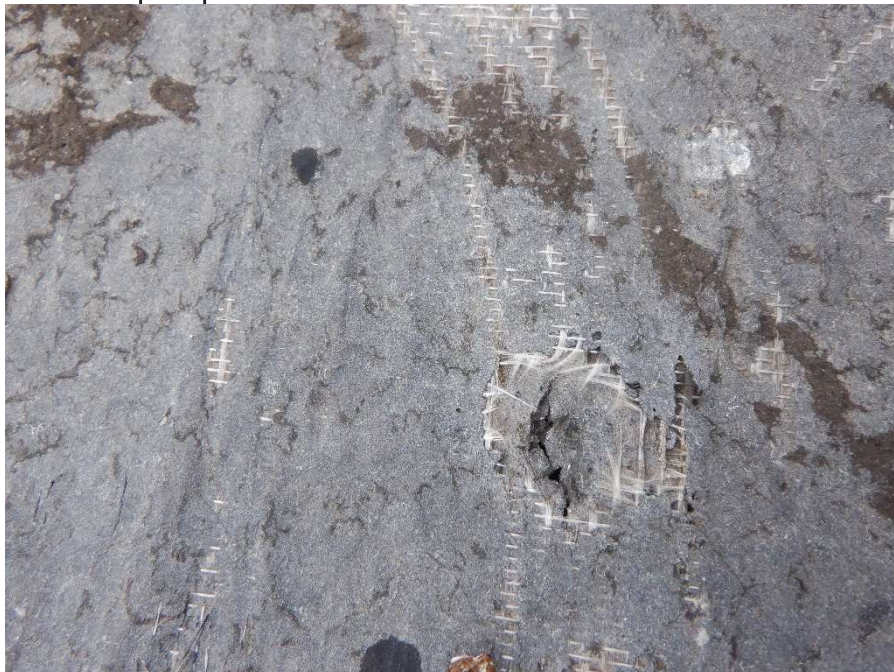
B-HCE Report Number 44-22003 – Pendant Properties, LLC Attachments

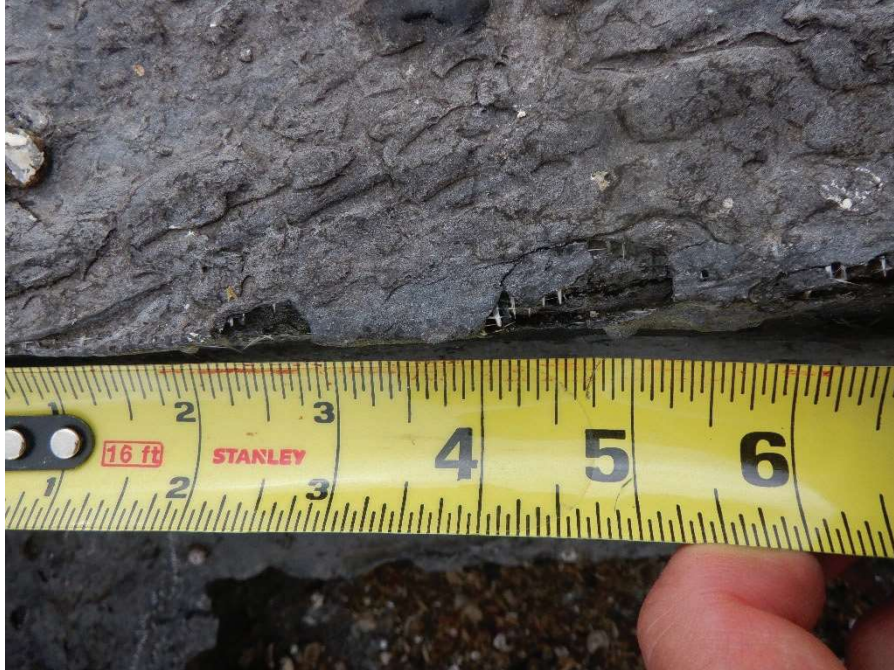
View of a spherical fracture in the bitumen along the penthouse parapet wall. Note the dark bitumen exposure.

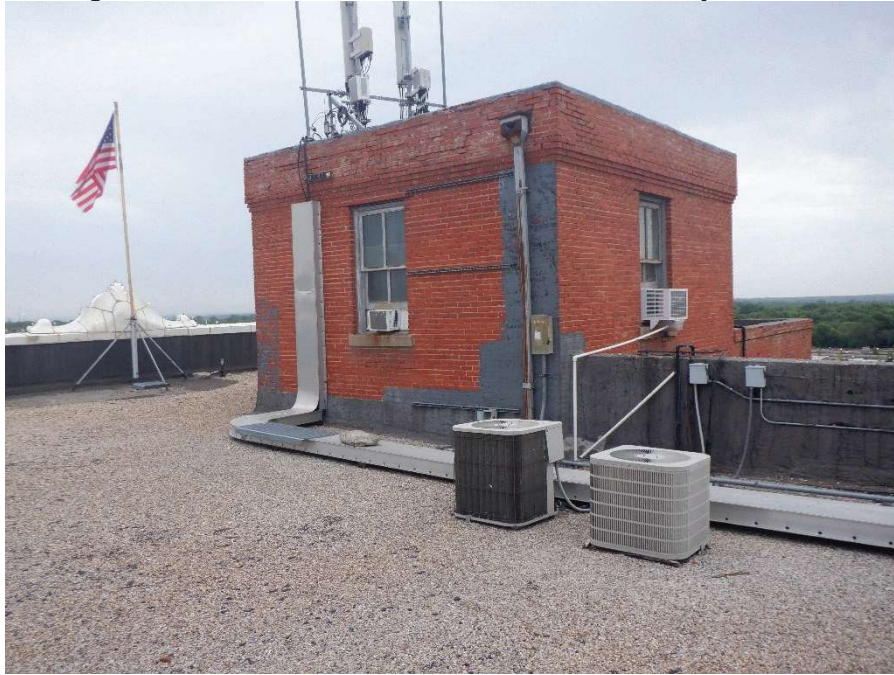
View looking northeast at the GB BUR over the 6th story roof.

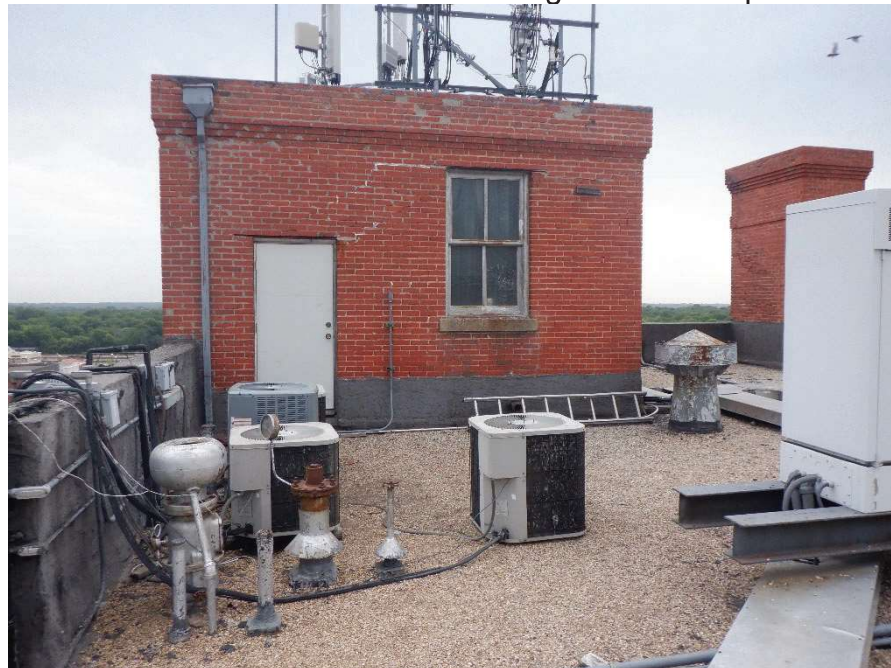
B-HCE Report Number 44-22003 – Pendant Properties, LLC Attachments

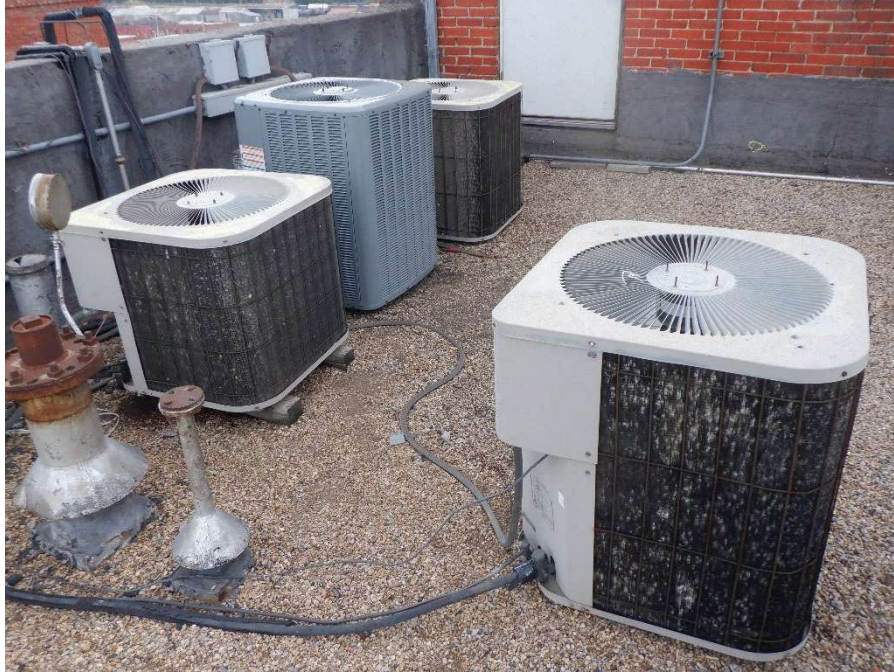
View of the wind-borne debris impact and hail-caused impact that dented the air conditioner covers, fan grills, and condenser fins.

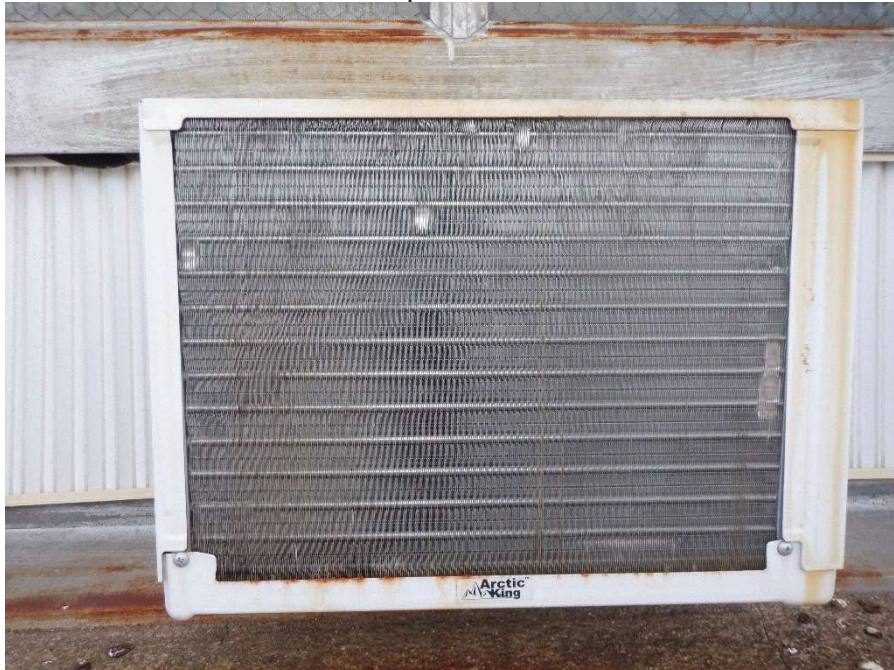
B-HCE Report Number 44-22003 – Pendant Properties, LLC Attachments

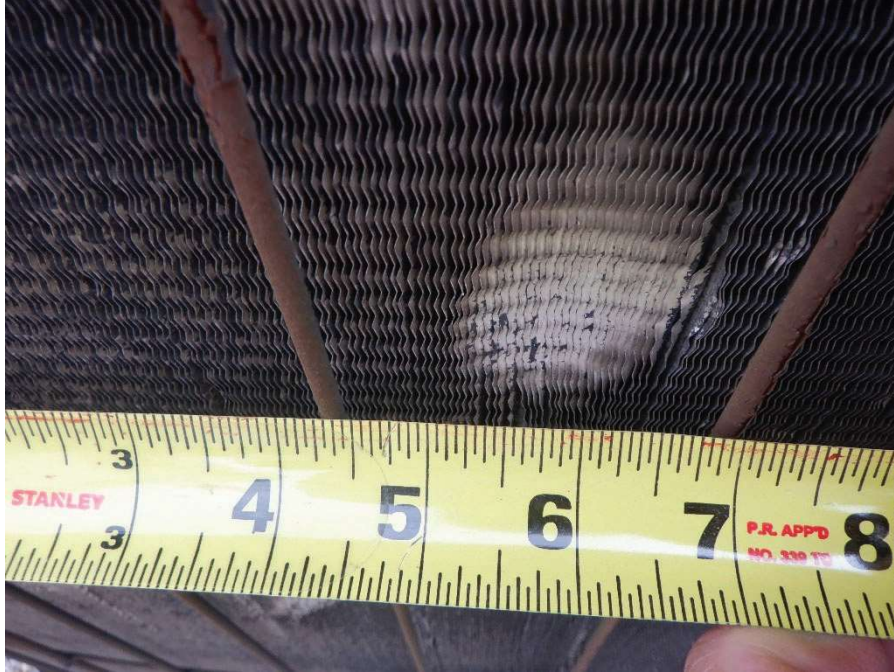
View of a shiny spherical hail-caused indentation approximately 1.5 inches in the condenser fins.

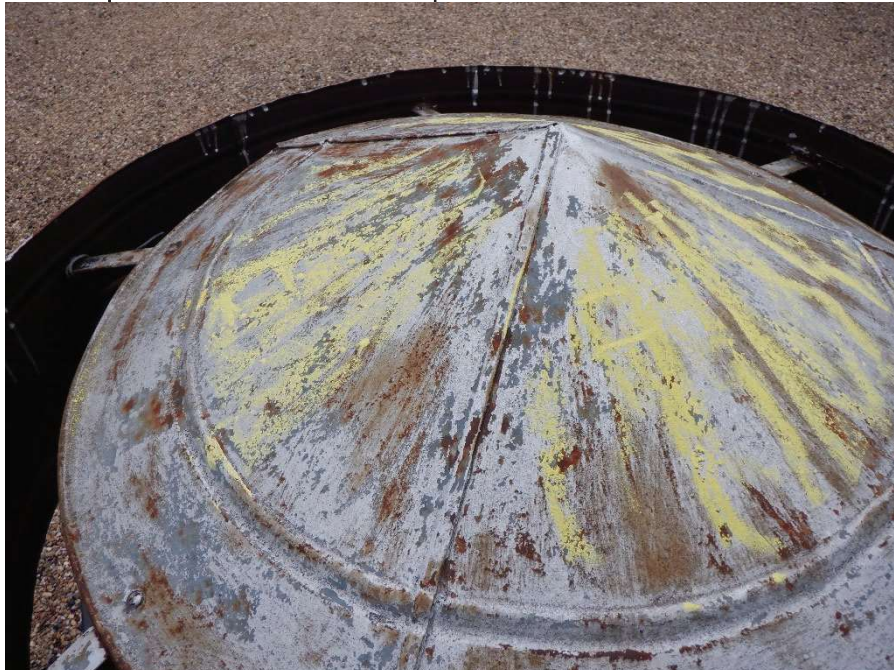
B-HCE Report Number 44-22003 – Pendant Properties, LLC Attachments

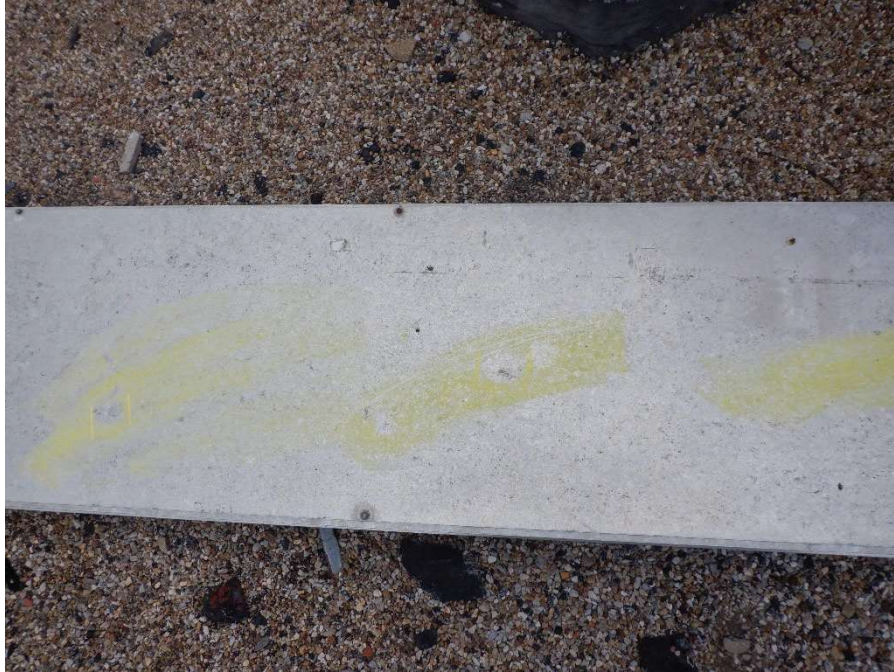
View of the wind-borne debris caused impact indentations in the conduit line metal cover.

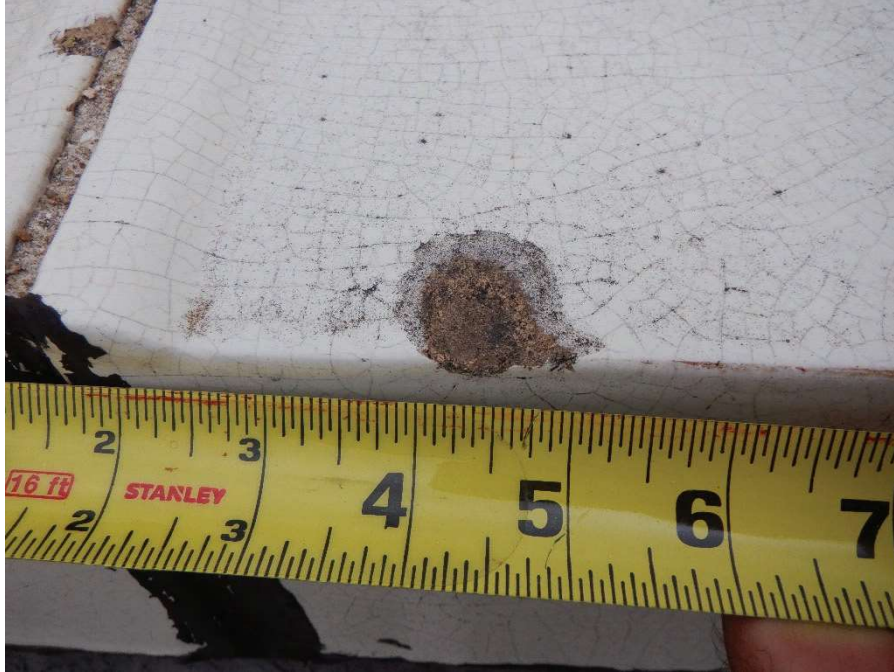
View of a spherical hail-caused fracture to the architectural glazed terra cotta tile parapet cap exposing the terra cotta.

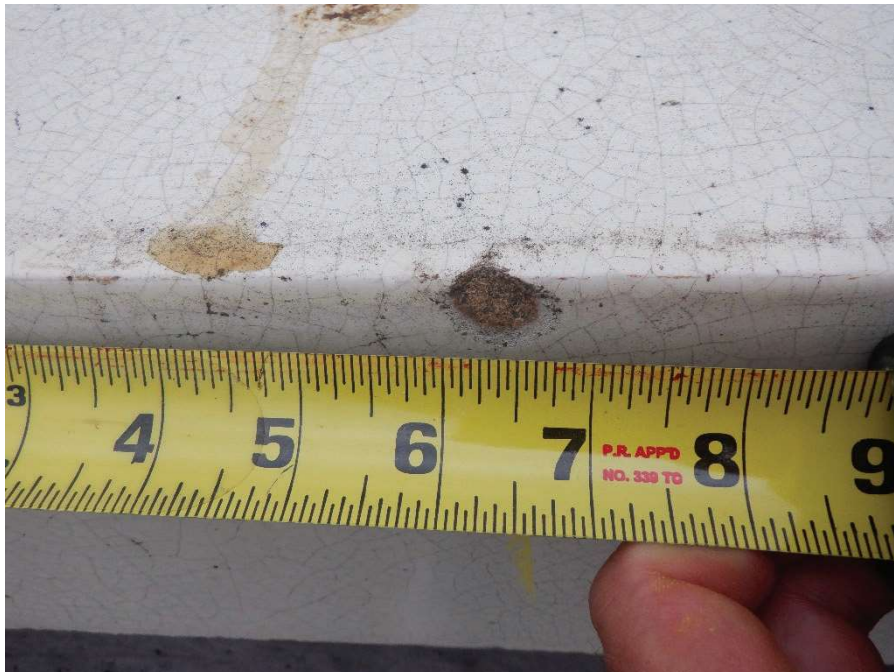
**B-HCE Report Number 44-22003 – Pendant Properties, LLC
Attachments**

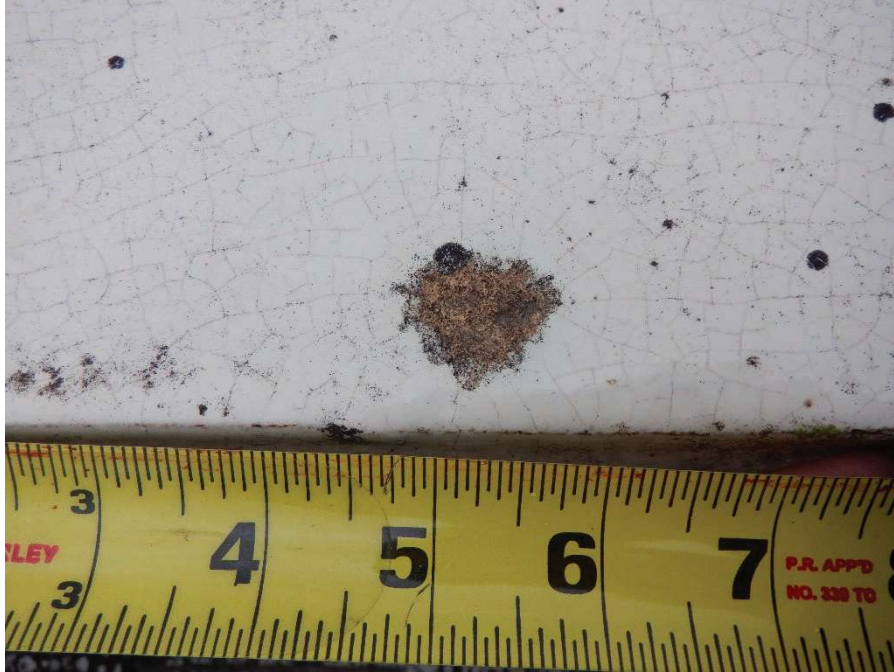
View of a spherical hail-caused fracture in the glazed terra cotta tile parapet cap.

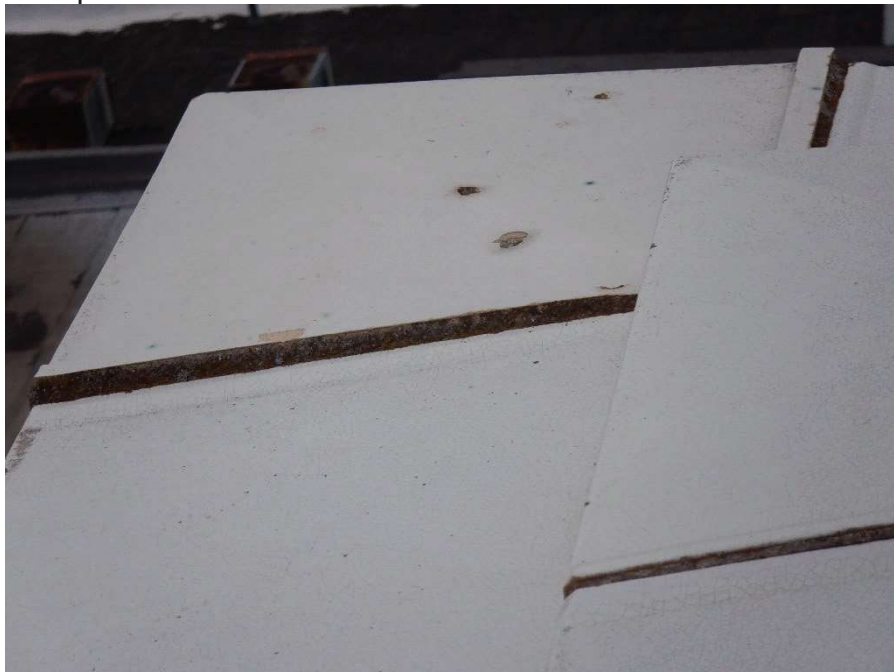
View of the spherical hail-caused fractures in the glazed terra cotta tile parapet cap.
